HCM-1200 Audit

Historic Monument Vacancy
and Distress Analysis

Locating the intersection of preservation and decay

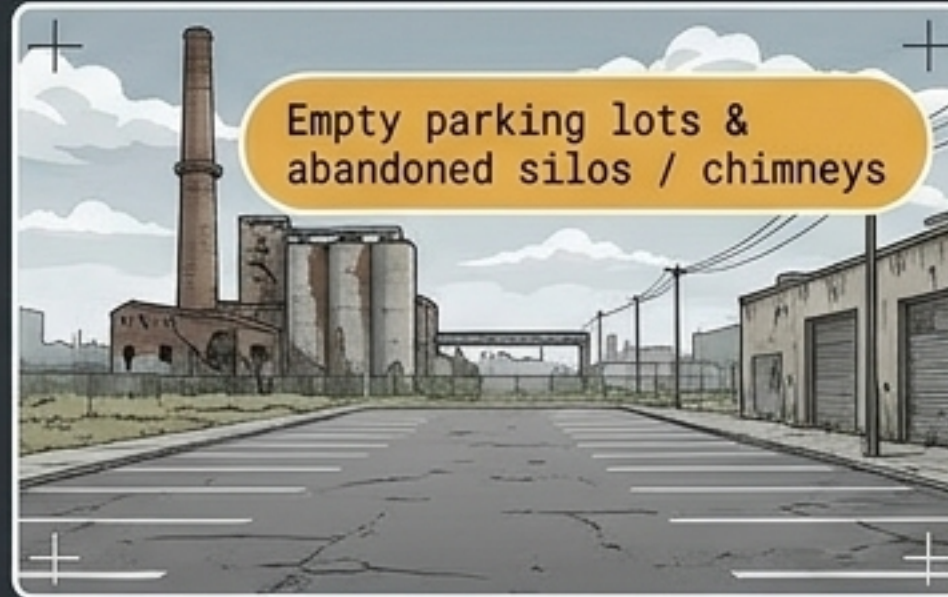
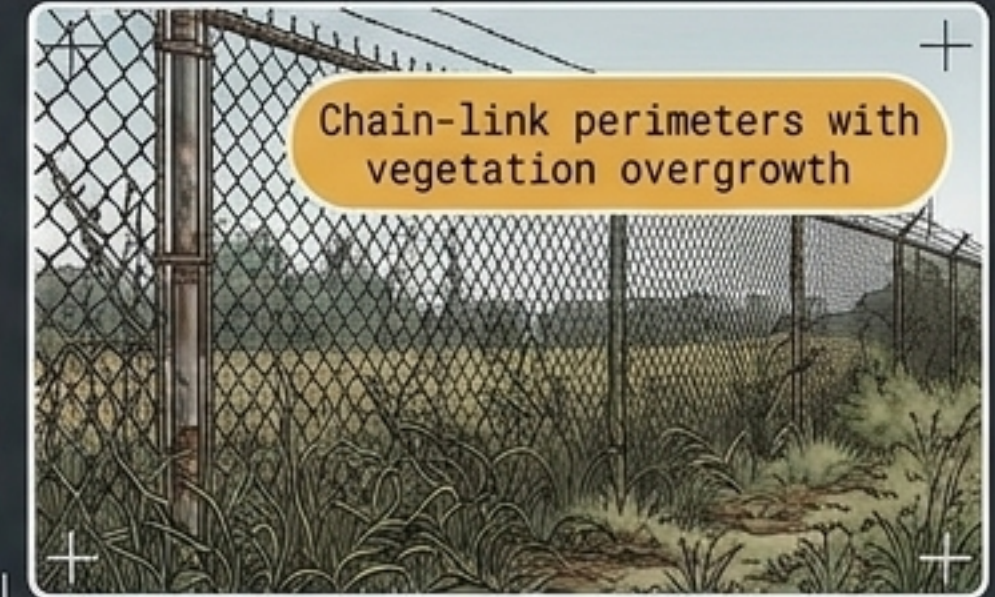
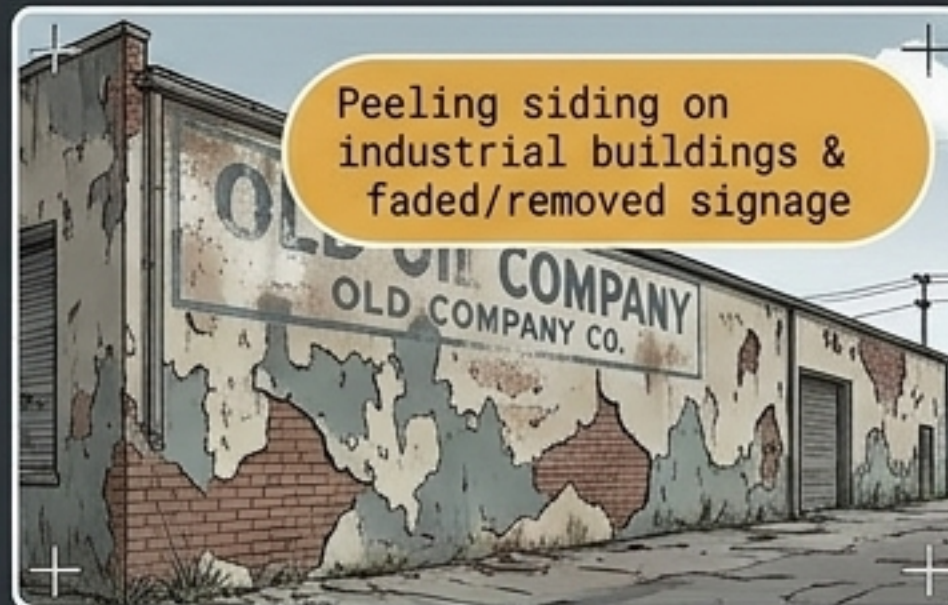
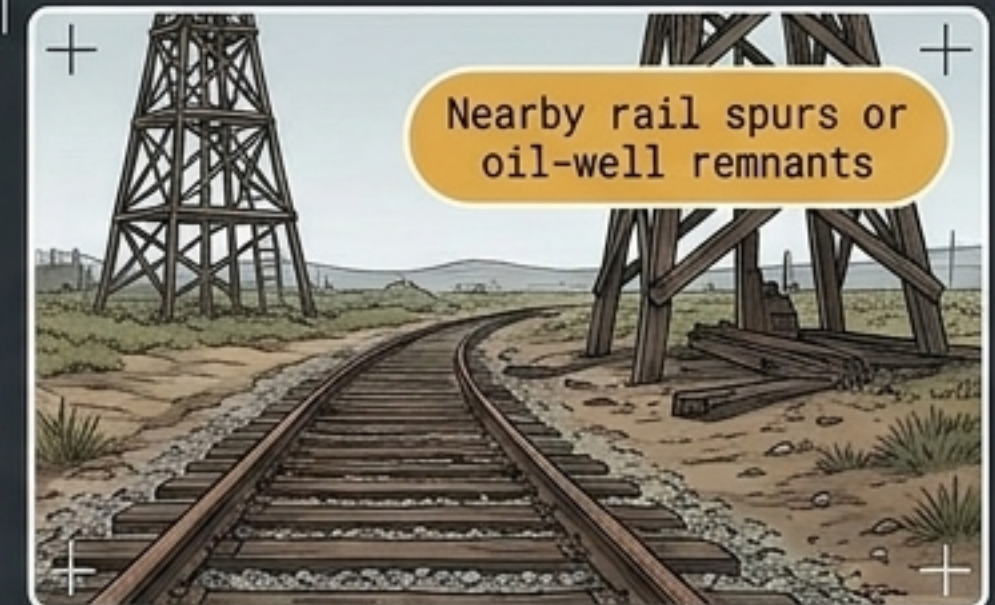
Type-1 Profile: Visual cues of industrial obsolescence

Type-1 properties are highly contaminated parcels where historic structures prevent standard redevelopment.

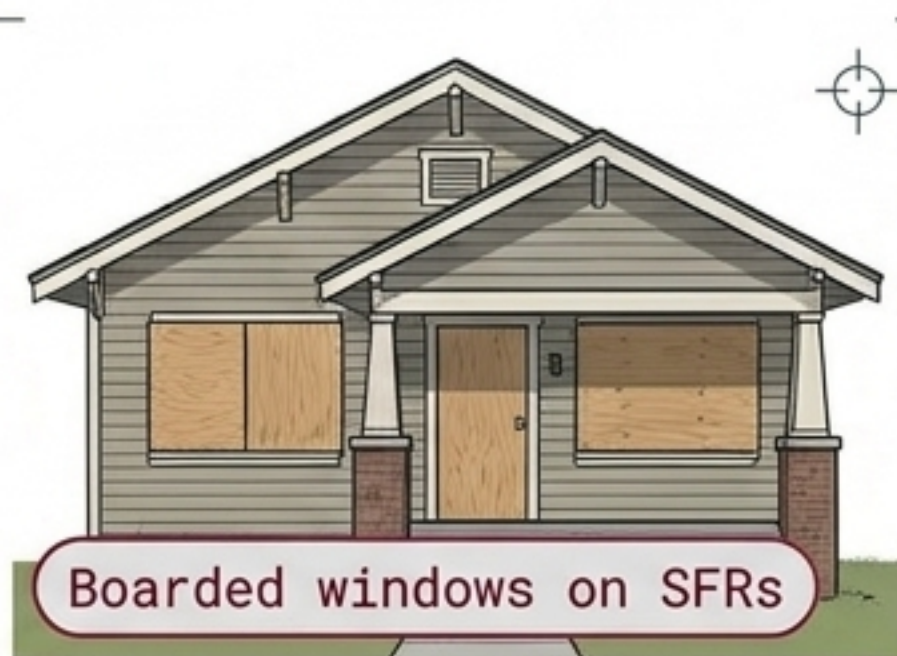
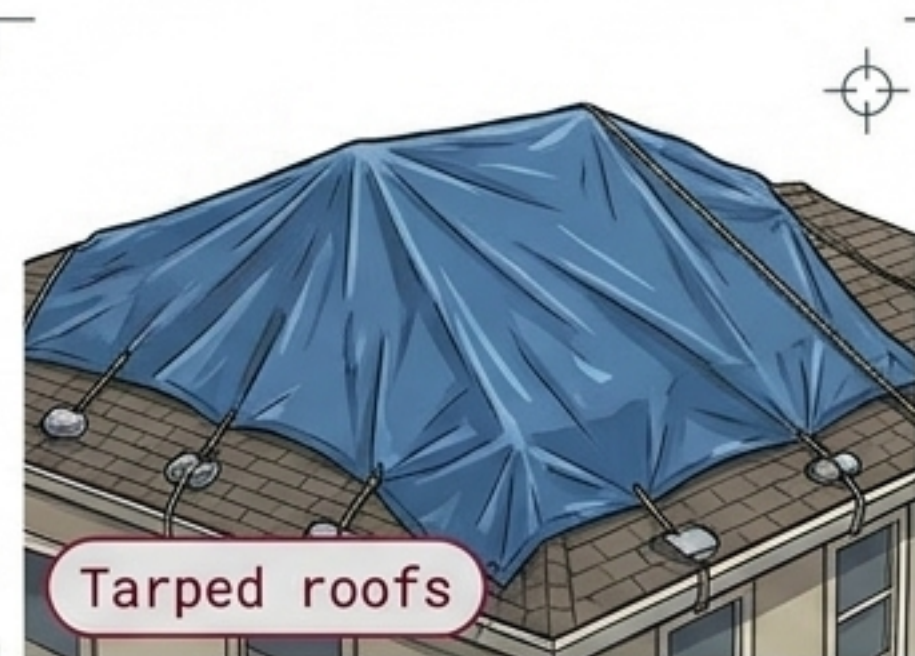
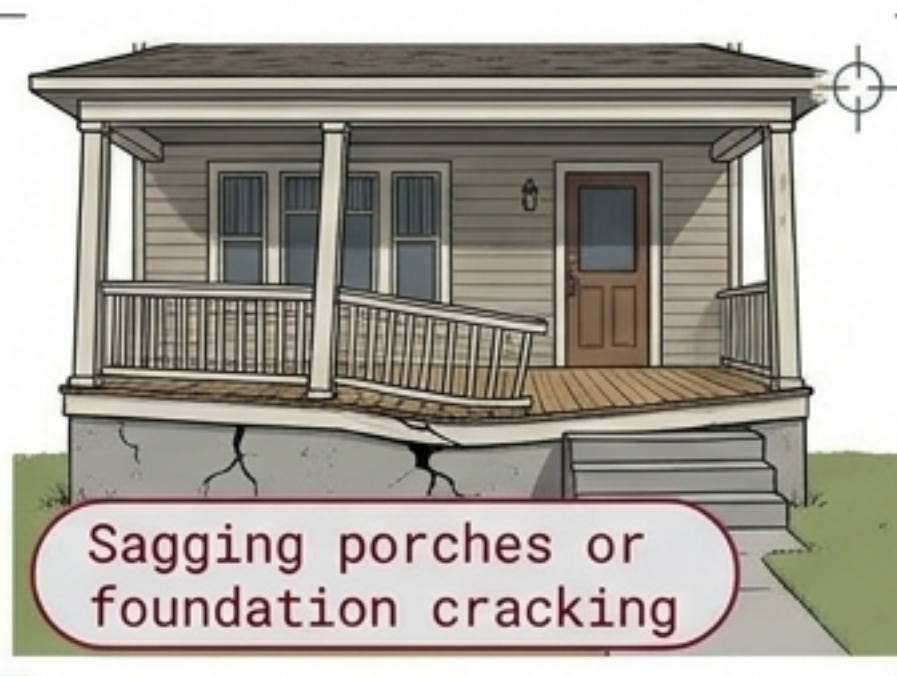
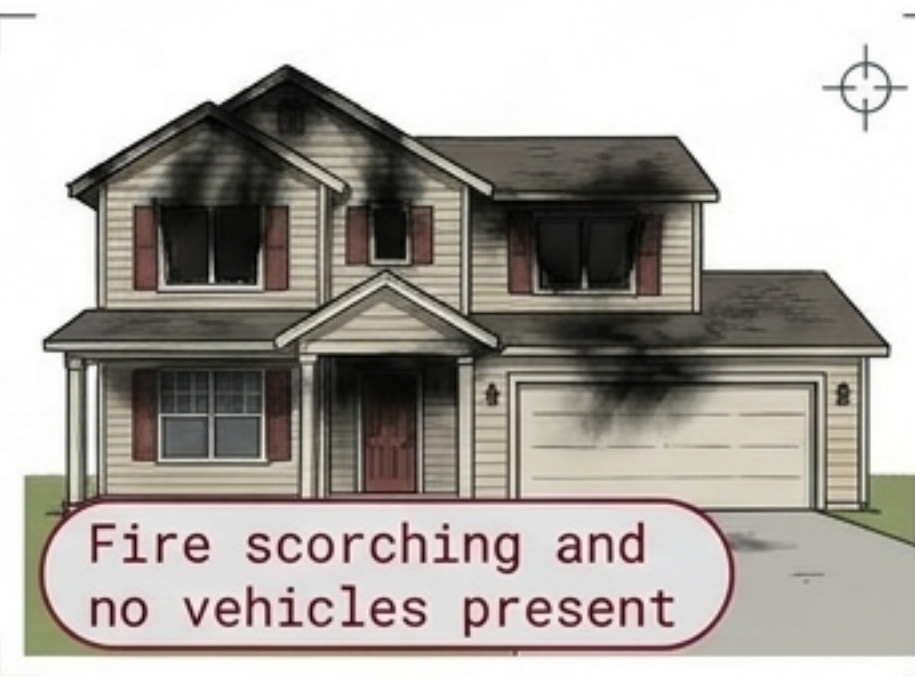
Type-2 Profile: Isolating standalone residential distress

What remains are freestanding residential parcels with independent distress signals.

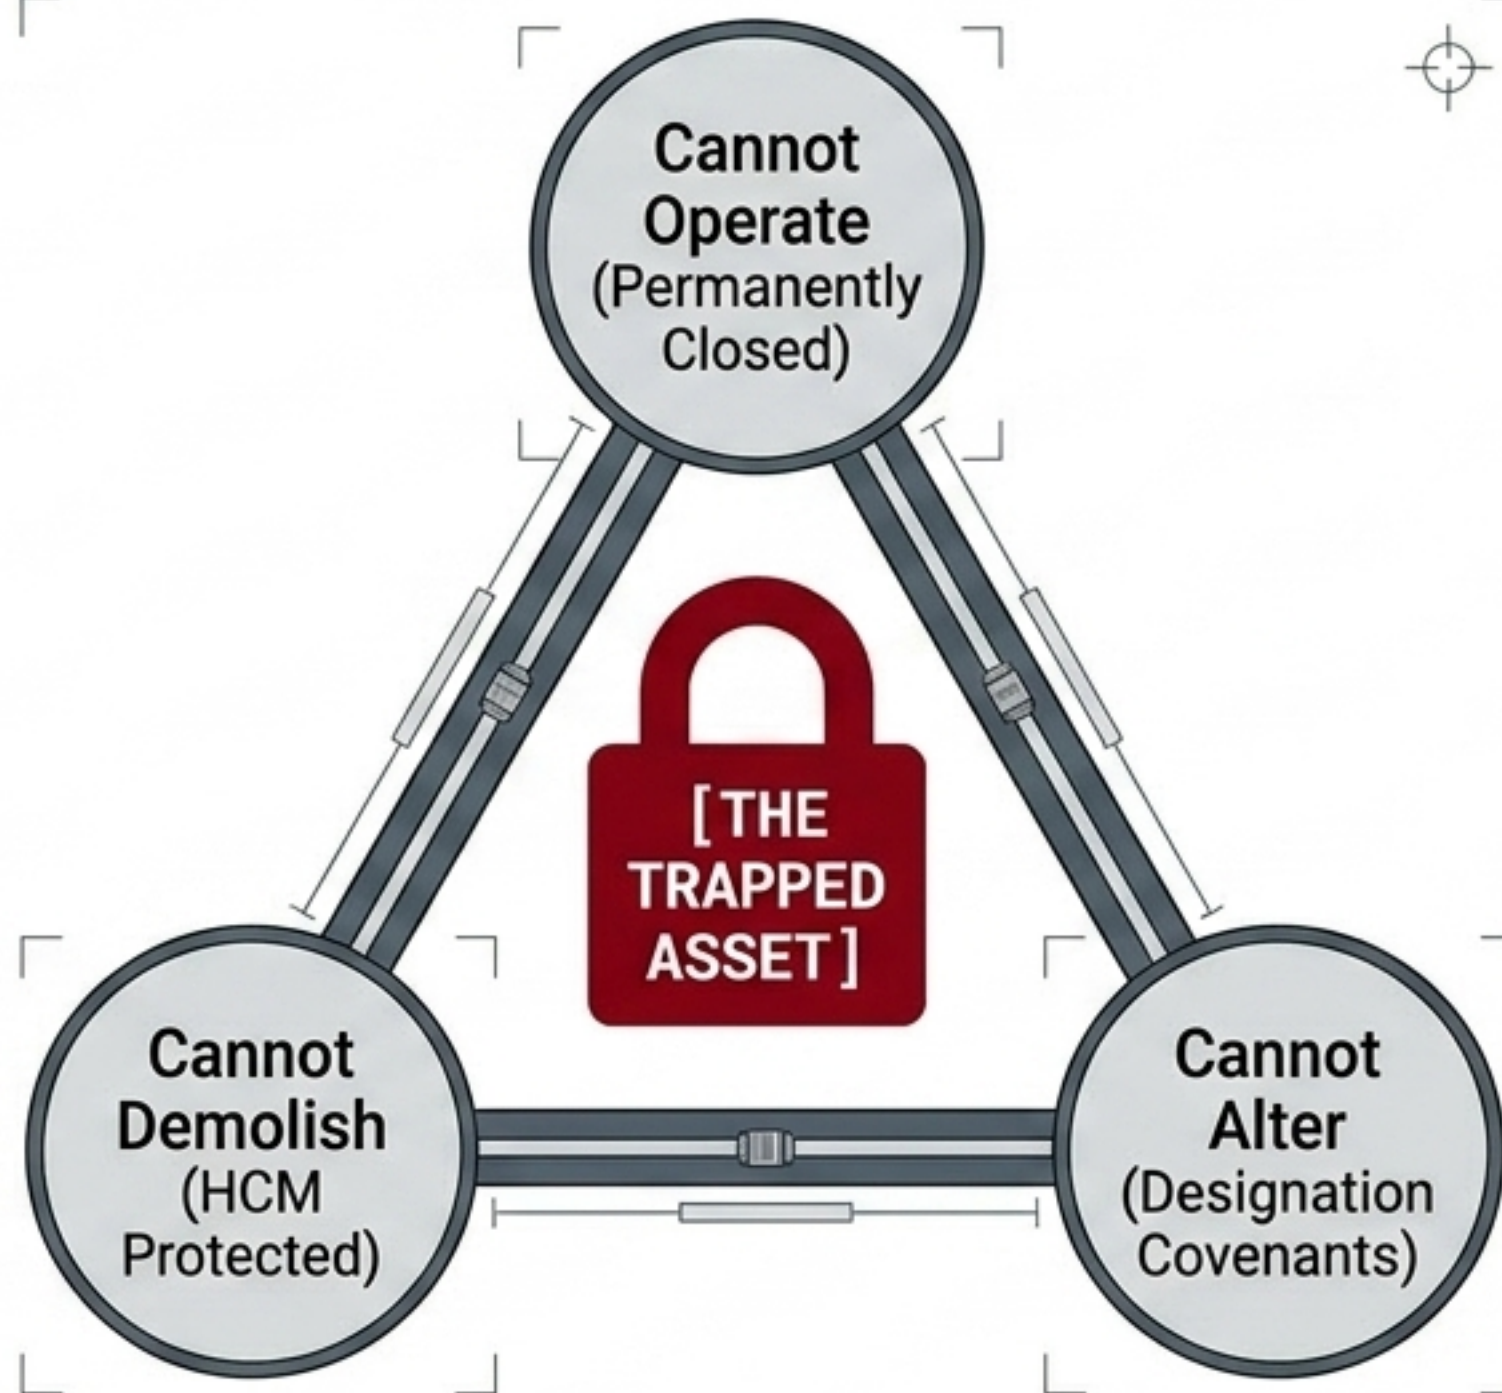
The Burnside Cluster: A textbook trapped pattern

Discovered on day one of the rubric build: HCM-423, 424, and 425 (Burnside Ave Apartments, 0.18 acres, designated 1989).

- 2 open CSR cases each.
- No recent permits.
- Neighboring property confirmed permanently closed.

[Currently queued for high-priority Tier-3 physical inspection]

Dispatch field teams to the Burnside Cluster (HCM-423/424/425) for grouped inspection efficiency.
